Horticulture Column

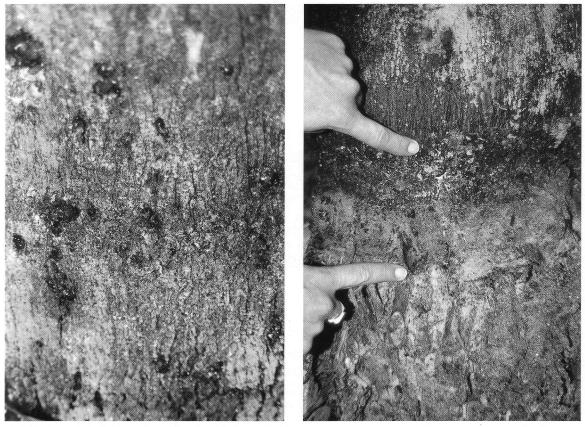
Q. We have a foxtail palm, *Wodyetia bifurcata*, planted in a prominent spot in our retail nursery. It grew well for several years but began to decline about six months ago. About two months ago, we noticed that the lower part of the trunk was oozing a thick sap (Fig. 1) and now it really looks like it is dying. Although this palm is planted in well drained soil, it is situated in a nursery area with containerized plants that receive irrigation on a nightly basis, so perhaps the soil is too wet. We would like to plant another if we can avoid losing it again. Kevin Riley, Florida.

A. To begin, I must confess that this palm was planted at the nursery where I am employed, and that I am the one who planted it. Close examination of the lower trunk of the dying palm and a little research led my colleagues and me to conclude that it was infested with ambrosia beetles. A wire 1 mm in diameter could be inserted into the tunnels or galleries made by these insects. Also, we were able to see the plugs of chewed up trunk material called frass that they push out of their galleries. In Florida, ambrosia beetles are members of the genus Platypus. Similar insects are found in many parts of the world, mostly in warmer regions. Ambrosia beetles can be economically important pests of recently cut, untreated timber, but they usually do not infest dried lumber or healthy living trees. Likewise with palms, they seek trees that are already dying from root, trunk or bud rot diseases. It might be possible to kill ambrosia beetles by spraying the trunk at the entrances to their galleries, but this action would not save the palm. The insects do not eat the wood of the palm trunk; rather, they feed on a fungus that they introduce and grow within the galleries they have created. This fungus is not pathogenic and is different from the fungus that may have been killing the palm.

After removing our dying foxtail palm we sawed the lower portion of the trunk into halves, lengthwise. This task was easier than it sounds since the trunk was nearly rotted through. We were fairly certain that the actual cause of death was a trunk-rotting fungal disease. By covering and sealing one of the trunk sections in a large plastic bag for four days we could see the fluffy white mycelium of the fungus advancing on the last bit of unrotted tissue near the base of the trunk. This disease could be any of several that can cause the death of a palm by rotting through its trunk.

In our experience, plants are often made susceptible to disease by one or more cultural conditions. Often these conditions are different than those which the species, in this case Wodyetia bifurcata, would experience in its natural habitat. The daily irrigation that our foxtail palm received was likely a contributing factor to its disease susceptibility, but a quick look at the base of the trunk revealed the simple and avoidable mistake that led to its death. In Figure 4 the lower finger indicates the point on the trunk that would be considered the correct planting depth, while the upper finger shows the actual level of the soil and mulch around the palm. Our palm was about 10 cm (4 in.) too deep. Particles clinging to the trunk showed that the palm was originally planted 5 cm too deep in the sandy soil, and another 5 cm of gravel mulch were added later.

1 (left). An early indication of trouble with this *Wodyetia bifurcata* was the presence of thick, gummy sap on the lower trunk. 2 (right). The lower finger indicates the base of the trunk which is the correct planting depth; the upper finger shows how deep the palm actually was, a difference of 10 cm (4 in.).

We hope this palm "post mortem" will help others avoid making the serious mistake of planting too deeply or of piling mulch up close to the trunks of their palms. It is a difficult lesson to learn by trial and error. Our foxtail palm was small when it was planted. It grew very nicely for several years and increased in size rapidly. It is very easy in such a case to blame the palm's death on insects or disease rather than improper planting and maintenance. We plan to plant another foxtail palm in our nursery, but in a place which is not so heavily irrigated.
